STRUCTURES NOTE 461

**STRUCTURAL DESIGN OF BFRP PATCHES FOR
MIRAGE WING REPAIR**

R. JONES and R. J. CALLINAN

JULY 1980

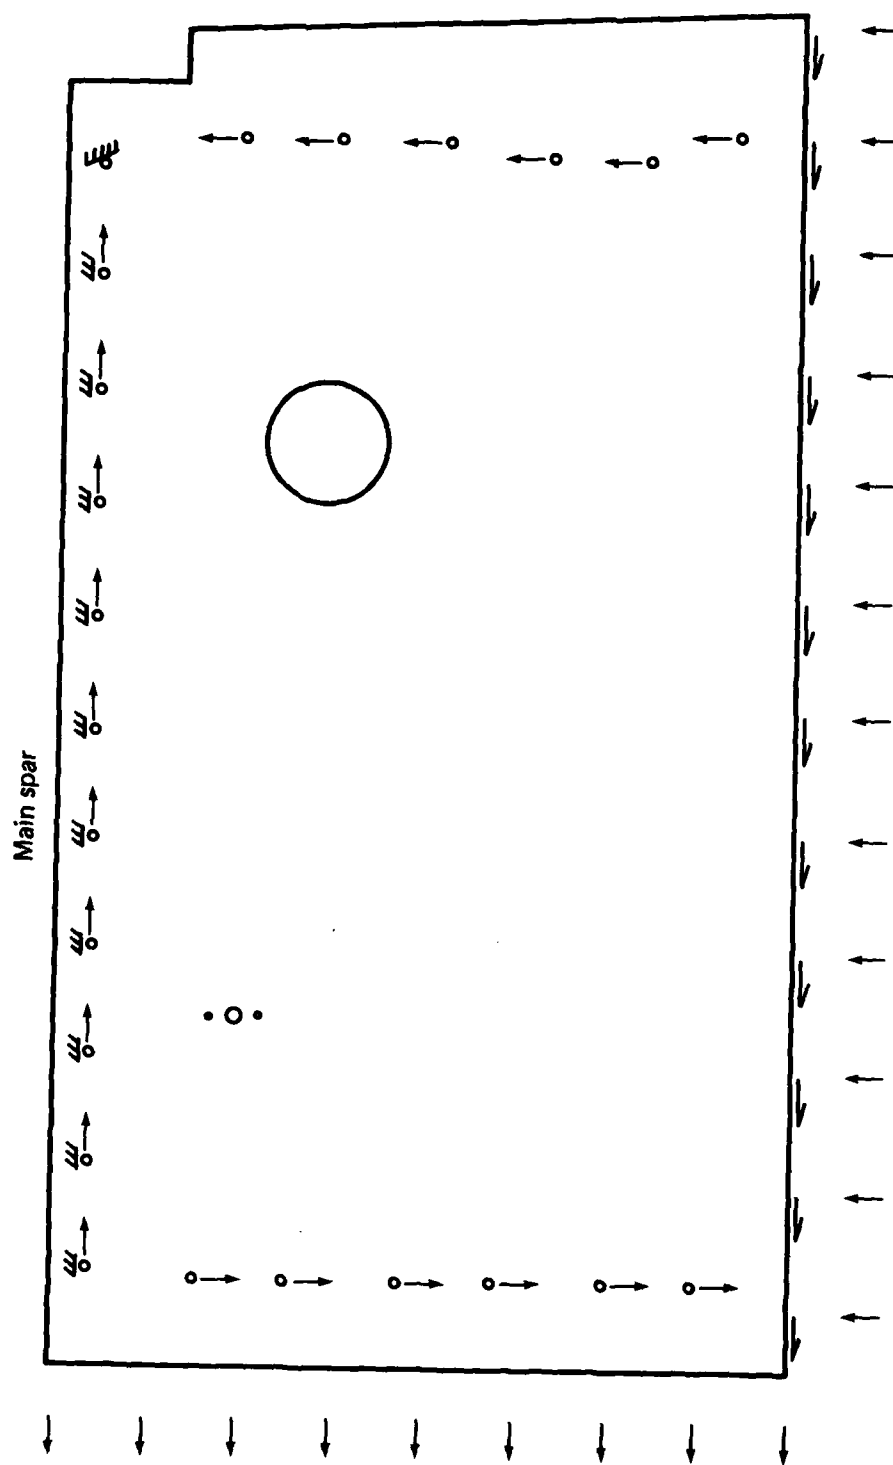
FIG. 2 LOAD DISTRIBUTION APPLIED TO PANEL

The stress distribution in the panel was obtained from the loading shown in Figure 2. This was adjusted to give results that agree with strain gauge readings, obtained from the ARL test, near the fairing hole of:

On the basis of this information a complex distribution of loads (see Fig. 2) was applied to the edges of the model for the wing skin panel shown in Figure 1. This load distribution gave the principal stresses at the strain gauge location in the test as
